PERMA-PATCH®

THIN COAT REPAIR

JULY 2010 - CARY, NC

North Carolina Department of Transportation Repairs Pavement Depression Instantly
With Perma-Patch Regular Mix and Thin Coat

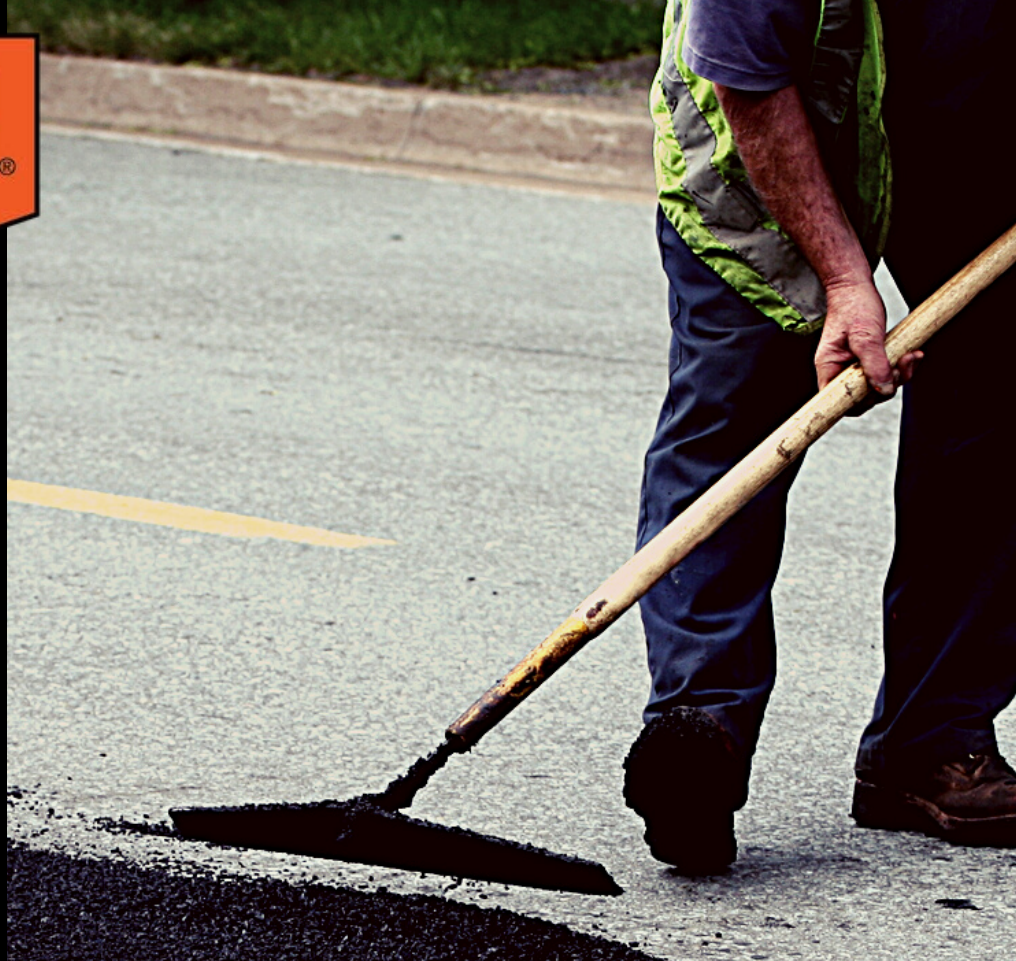
In July 2010, a pothole developed in a travel lane of a busy rural road. Due to the pothole, water penetrated the road's surface and created a 1/4" depression, increasing the danger for drivers on the road. Since the North Carolina DOT D5 Streets Maintenance team previously used Perma-Patch on other pavement repairs, they quickly entrusted Perma-Patch to repair this depression as well.

Perma-Patch Regular Mix was used to repair the pothole and a thin coat to repair the shallow 1/4" depression. A vibratory compactor plate was used on the skin coat application to create a water-tight bond.

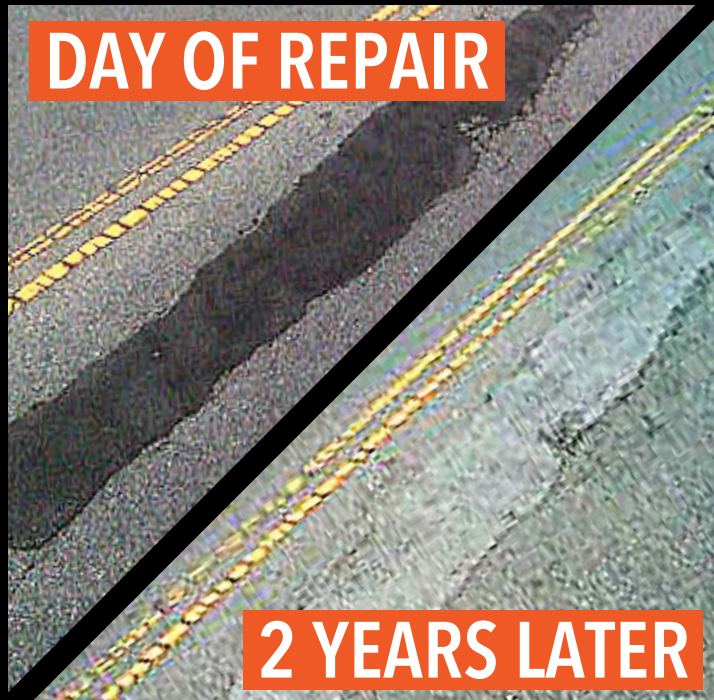
DAY OF REPAIR

After two years, the repair was reported to still be effective.
